melett

LACK OF LUBRICATION /OIL STARVATION

What is lack of lubrication and oil starvation?

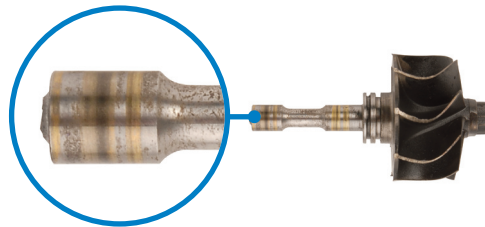
Material transfer from journal bearing

- Oil supply is critical to the turbo, please ensure the oil flow is correct
- Always remember to prime the replacement turbocharger with oil before fitting
- Do not use silicone on oil gaskets as it can easily become detached and block oil passages
- Clean or replace oil inlet pipes to remove carbon deposits or sludge that could restrict oil flow to the bearing systems
- Use fresh oil and new oil filters (which have been recommended by the engine manufacturer) when fitting a replacement turbocharger
- Allow time for the engine to warm up at the start of each journey and cool down at the end

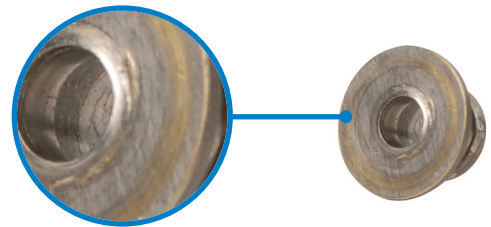
Material transfer from thrust bearing

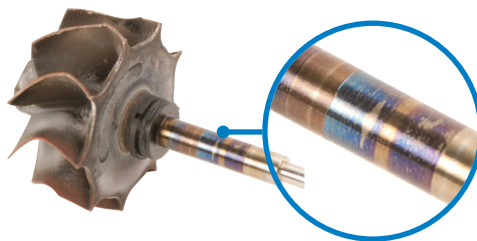
Discolouration to diameter of shaft & wheel

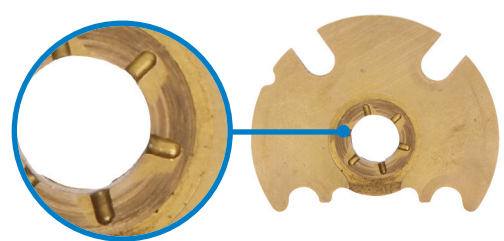
Excessive wear to thrust bearing

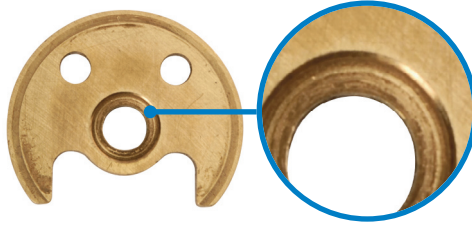
Excessive wear to thrust bearing

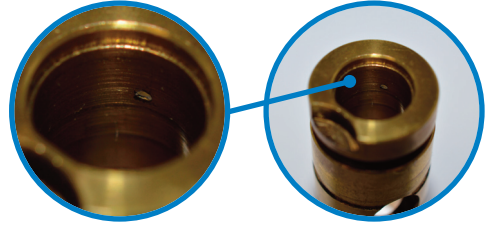
Excessive wear to journal bearing
