melett

PRECISION ENGINEERED
TURBOCHARGERS & PARTS

OIL CONTAMINATION

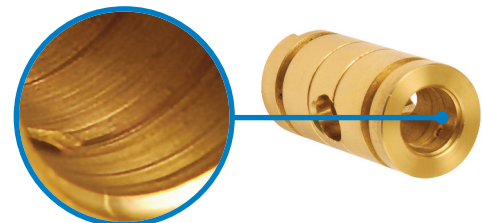
- If the oil filter is damaged or a poor-quality oil filter is used
- Excess moisture can lead to premature oil degradation, increased corrosion and increased wear
- High carbon build up present in the engine can quickly contaminate new oil
- Contamination of new oil whilst servicing (accidental)
- Unchanged oil containing detergent deposits can become very abrasive to the turbos precision components
- Engine wear, which can leave swarf deposits in the oil
- Degrading oil caused by excessive temperatures or extended service intervals
- Internal engine leaks, such as fuel or coolant mixing with oil supply
- Residue from blasted components, during the remanufacturing process
- Particles from carbon build up in oil feed pipes

Scoring to journal bearings

- Using new oil and filters helps to reduce the risk. We advise that filters recommended by the engine manufacturer are used when refitting the turbo
- Replacing or cleaning the oil inlet pipes and in-line micro filters helps to prevent carbon deposits entering the oil flow to the bearings
- Take care when changing oil during servicing to prevent accidental contamination
- Check for engine wear that could leave swarf deposits
- Check the vehicle is up to date with services
