# melett

## OIL CONTAMINATION

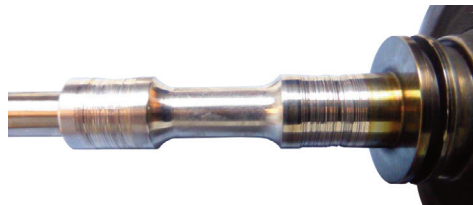
- Scoring to thrust components
- Scoring to journal bearings
- Scoring to journal bearing diameter of shaft and wheel
- Smell of fuel in the oil
- Particulates in the oil

Scoring to thrust parts

Scoring to journal bearings

- Using new oil and filters helps to reduce the risk. We advise that filters recommended by the engine manufacturer are used when refitting the turbo
- Replacing or cleaning the oil inlet pipes and in-line micro filters helps to prevent carbon deposits entering the oil flow to the bearings
- Take care when changing oil during servicing to prevent accidental contamination
- Check for engine wear that could leave swarf deposits
- Check the vehicle is up to date with services
